Manhole Inspection Summary

Manhole # S45I__043MH

Insp Date: **4/25/08 2:23 PM**

Location Address: **1833 s wolfe st**

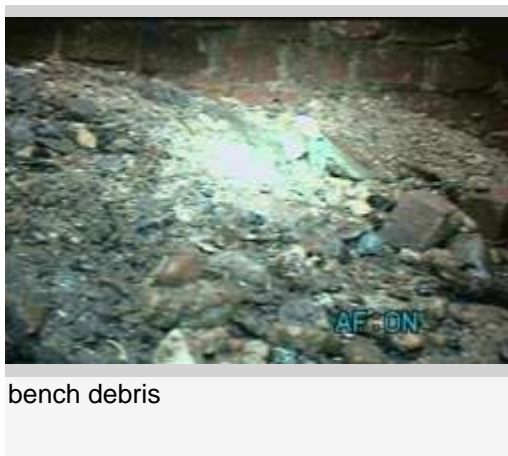
Defect 4

Condition: ☐ Sound ☐ Cracked ☐ Root Intrusion ☐ Deteriorated ☐ Leaks ☒ **Debris**

bench debris

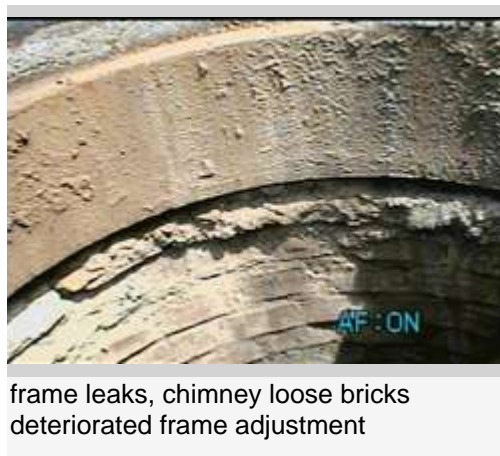
Defect 3

☒ **Leaks**

Condition: ☐ Sound ☐ Cracked ☐ Root Intrusion ☒ **Loose Brick** ☒ **Deteriorated**

Infiltration: ☐ None ☒ **Joint** ☐ Cracks ☐ Mortar ☐ Roots ☒ **Wall**

frame leaks, chimney loose bricks
deteriorated frame adjustment

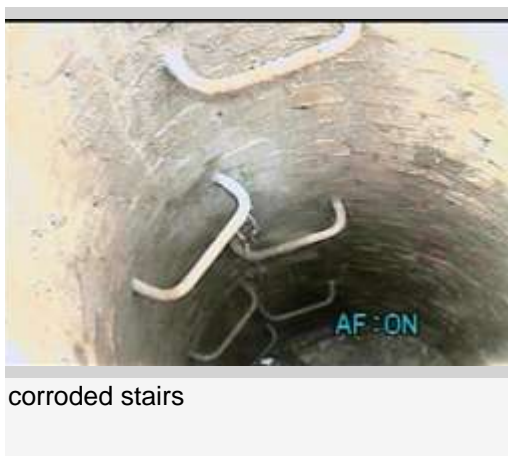
Defect 2

Count: **6** Missing: **0** ☒ **Corroded**

corroded stairs

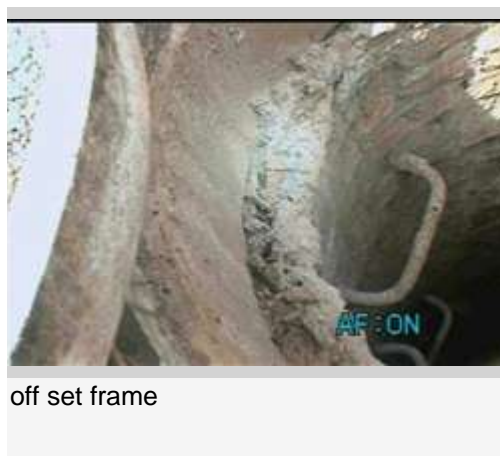
Defect 1

Offset: **3** (in.)

off set frame
